BUTTE HIGHLANDS JOINT VENTURE

Butte Highlands Joint Venture Mine Design, Operations, and Closure Conference Mine Water Treatment Short Course

May 3, 2015

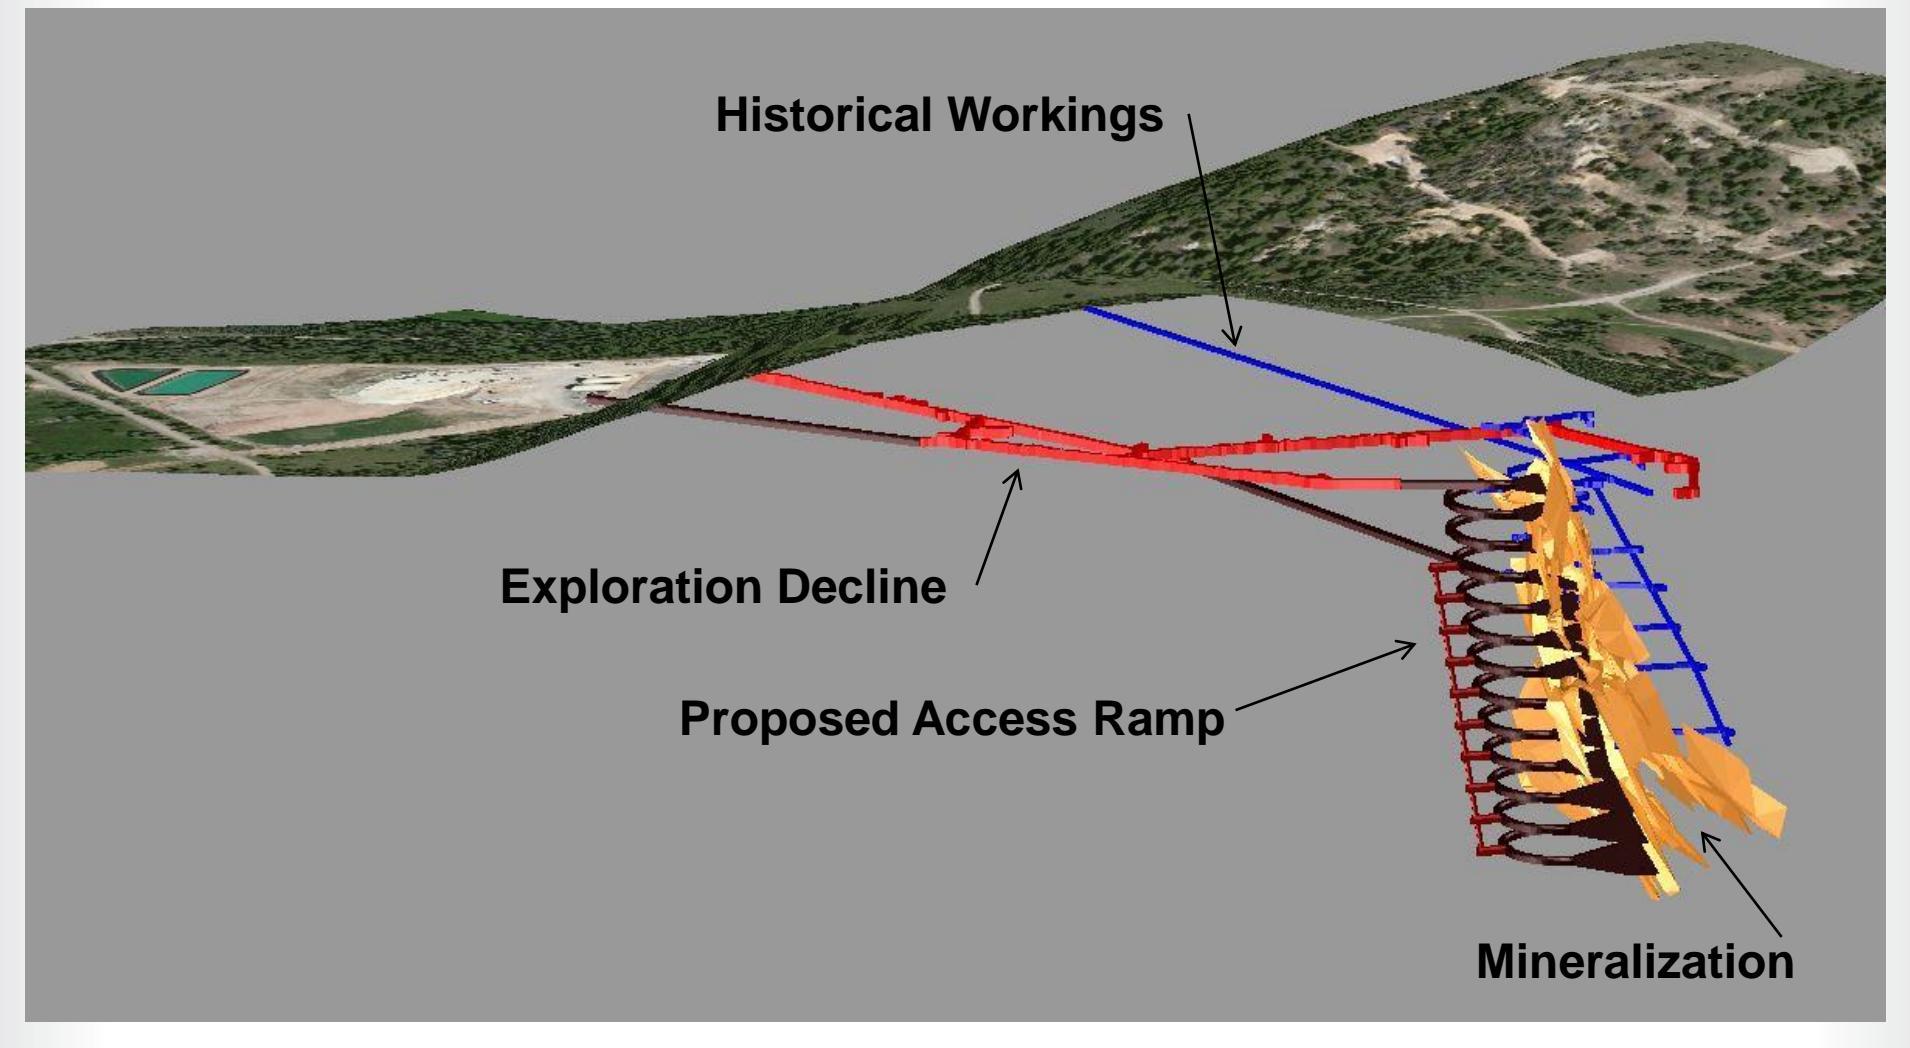
3D Model Looking Northwest

Development Concept

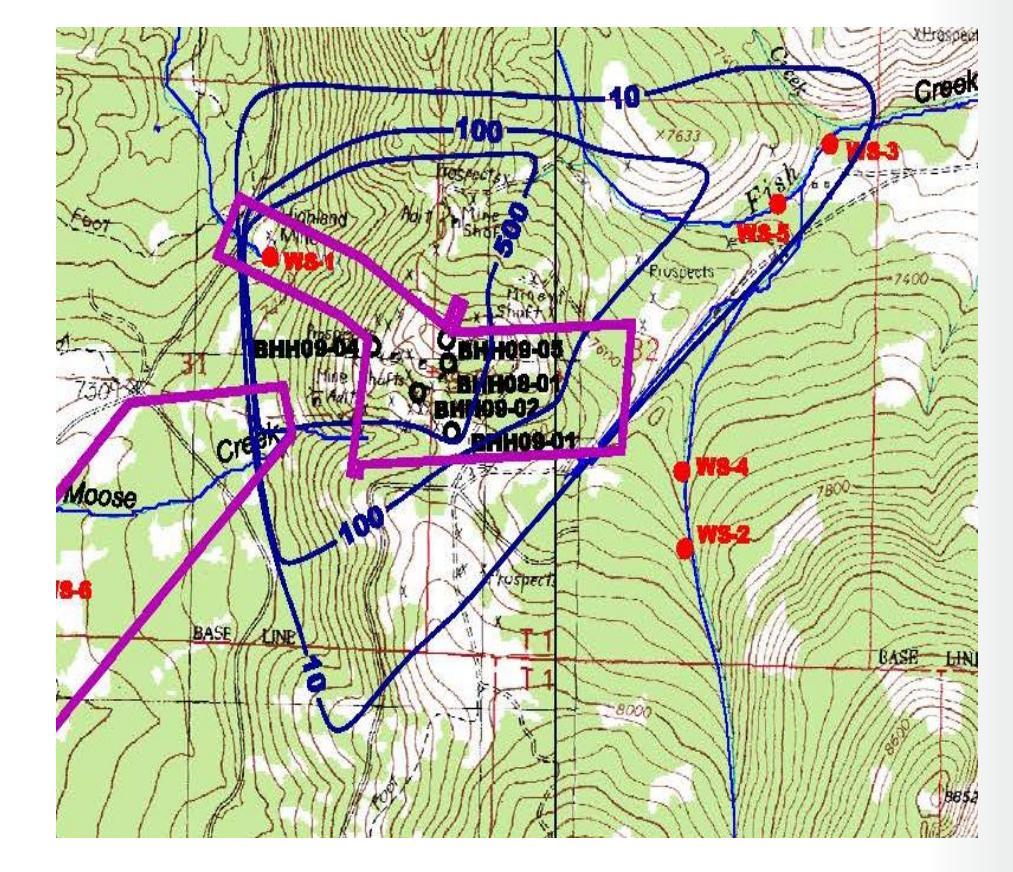
Permitting— Hydrogeology and Discharge

Current groundwater surface at ~7,339 ft elev.

- Controlled by historic Highlands Mine adit
- Discharge as Basin Creek headwaters

Aquifer dewatering test

- Predicts up to 750 gpm dewatering rate
- ~7-8 years estimated postmining groundwater recovery

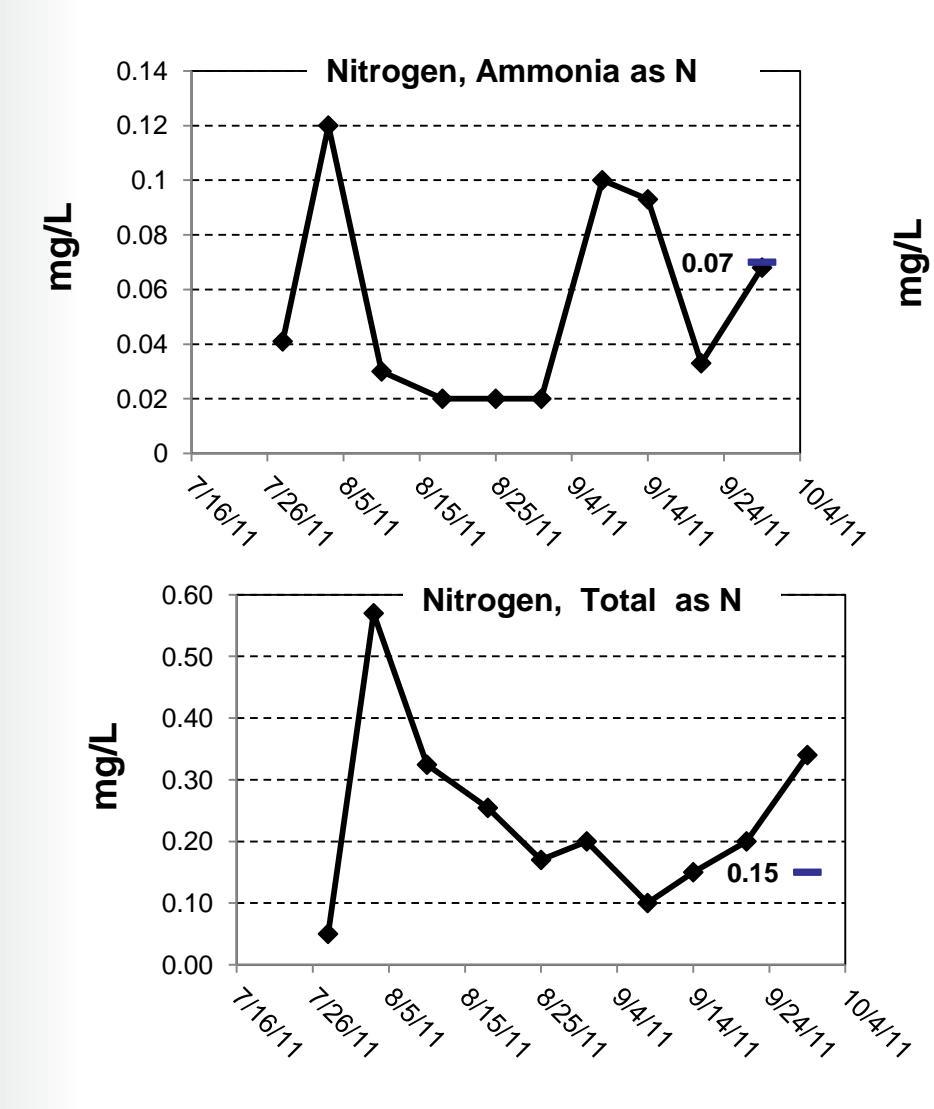
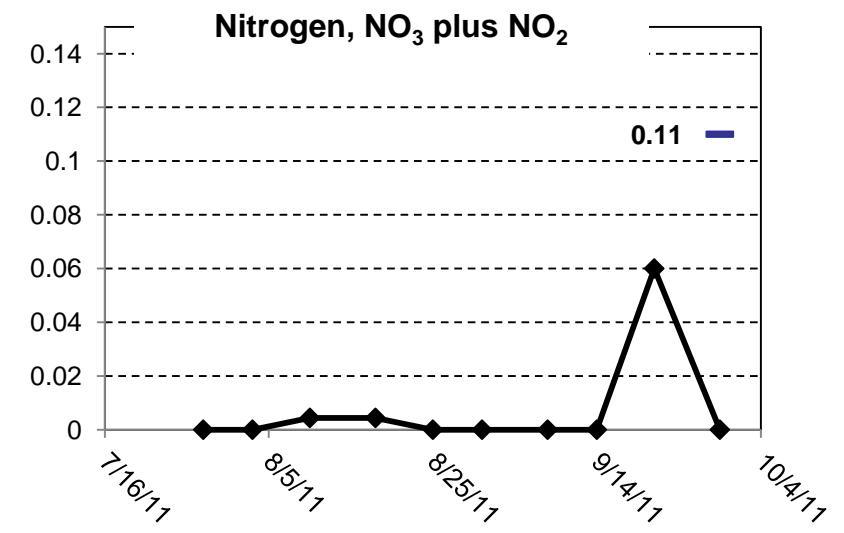
Outfall Water Quality and Discharge Limits

- Critical Parameters requiring treatment
 - As, Cu, Pb, Ni,
 - Zn, Hg, P, N

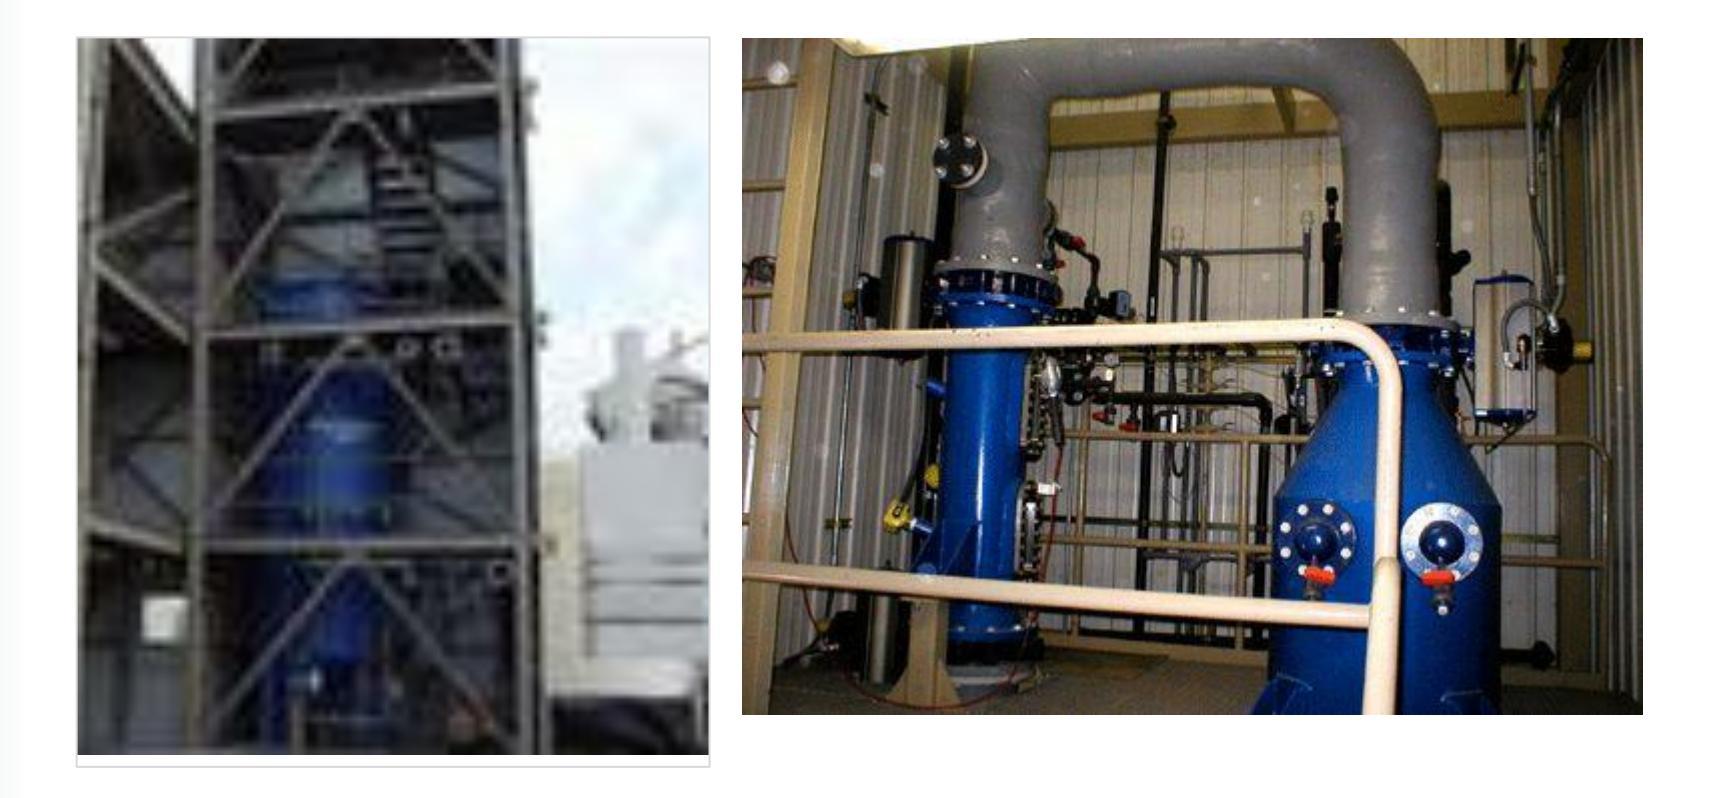
Water Treatment: Ion Exchange

- Severn Trent Higgins Loop
- > 750 GPM capacity

- TSS removal through coagulation/filtration
- Ion Exchange treatment bench and pilot testing
 - 16 regulated contaminants with 10-100x spikes for fluoride, ammonia, nitrate, and total Nitrogen
 - Resin working capacity estimates:
 - Cation resin: ~1.3 Eq/L (strong acid cation exchange)
 - Anion resin: ~1.5 Eq/L (weak base anion exchange)
- CO₂ stripping
- pH adjustment

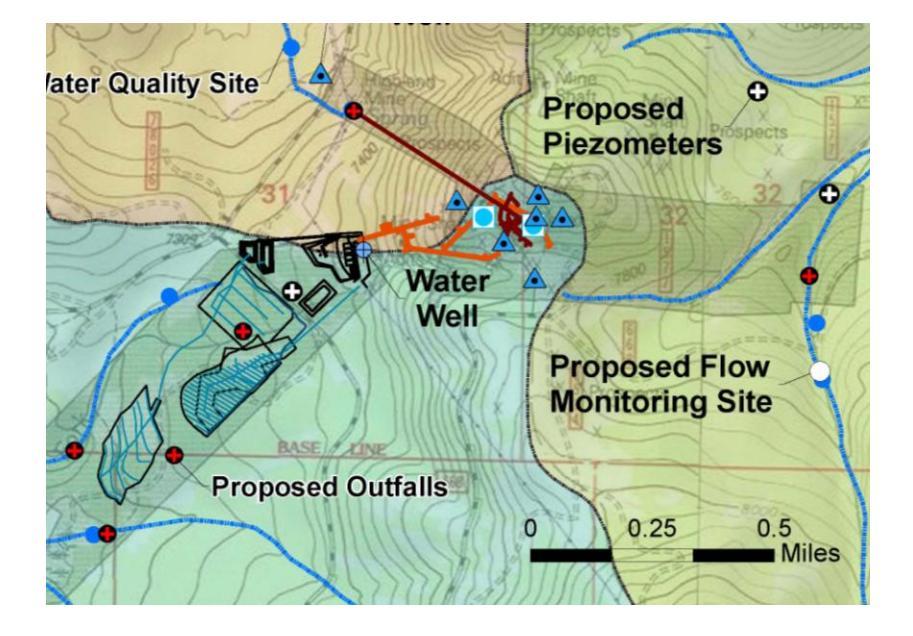
Treated Water Management

> Treated water discharge:

- Basin Creek: release inside historic portal
- Moose Creek: pipe to Outfalls 003 and 004
- Fish Creek: pipe to Outfall 002

Mine sump water: potentially pipe to LAD infiltration system under EPA UIC Permit
